Two Avenues for Data: Rosslyn Chapel as A Terrestrial Scanning Case Study

**H. CHRIS MCGREGOR, DAVID S. MITCHELL, LYN WILSON, Edinburgh
DOUGLAS K. PRITCHARD, Glasgow**

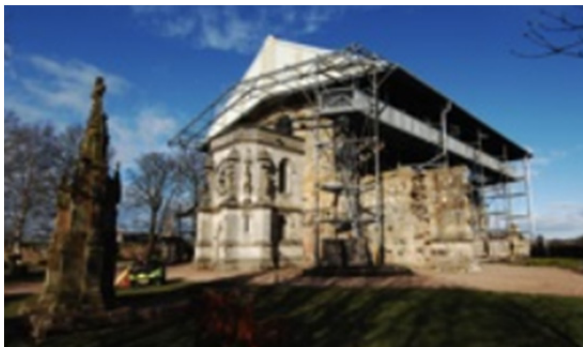
Image One: Chapel exterior with temporary protective metal shed roof

In 1995 it was determined that the saturated stone and high levels of humidity had to be immediately addressed and in 1997 a temporary, freestanding steel roof was erected over the entire Chapel to allow it to dry out.

The ScanStation 2 is capable of a point-cloud scan density of 1.2 mm x 1.2 mm at 50 meters but because of the considerable data overlap from the numerous scan stations, the typical set scan density was 8 mm x 8 mm. The tripod-based ScanStation 2 scanner is capable of acquiring data from the line-of-site of the scan head, approximately 1.4 m off the ground. Exterior scanning was done from the ground but also on the temporary roof walkway (Image One) and on the Chapel vault (Image Two).

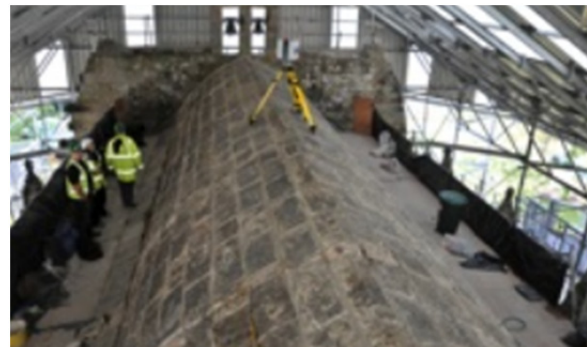
Image Two: Chapel vault with original exterior vault roofing removed and HDS6100 scanner in place

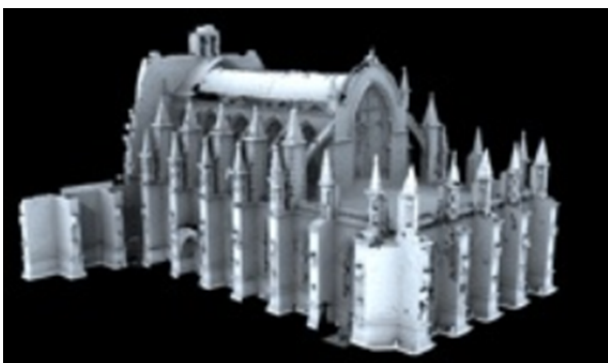
Image Five: 3D Mesh Model of Chapel exterior – metal shed roof virtually removed

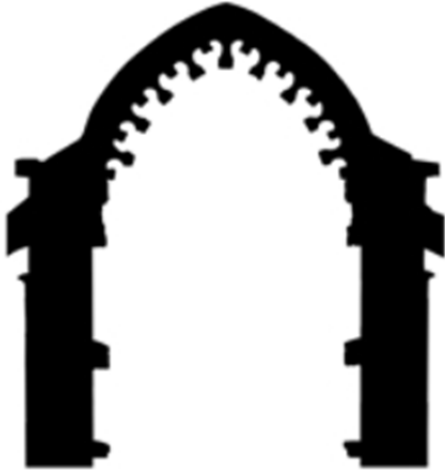
Image Seven: Cross-Section of Chapel Vault

To provide the roofing contractor with a better understanding of the depth of the vault, eight lateral cross-sections and four longitudinal sections were derived from the combined interior and exterior point cloud data (Image Seven). The location of the sections were initially selected by reviewing the 3D point data in Leica Cyclone then drawn up in 2D CAD format using Autodesk Architectural Desktop in combination with the Leica Cloudworks plugin.

In this situation, the terrestrial scanning system proved beneficial over traditional survey systems such as the Total Station in that the scanner provided comprehensive surface documentation (millions of points) as opposed to individual point documentation. As both the exterior and interior were fully scanned and properly registered, sections could be easily cut through the data to provide the contractor with a precise depth of the stone vaultⁱⁱⁱ.

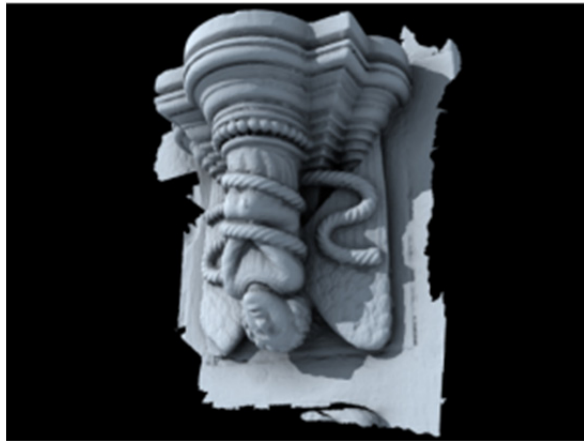
Image Ten: Detail rendering of the Lucifer sculpture

Ten interior sculptures – The Mason and Apprentice Pillar, the Dance of Death, Lamb of God, Green Man, Lucifer, Knight on Horseback, Angle Holding a Heart, Seven Virtues and Seven Sins – were individually scanned using a Percepteron sub-centimetre hand scanning system at 0.5 mm resolution.

The acquired scan data was converted into a 3D mesh and ‘data holes’ filled using PolyWorks. The data was then imported into 3D Studio Max, textured and animated at 1080p. The developed content was then integrated into a series of touch screen panels with corresponding descriptive text.

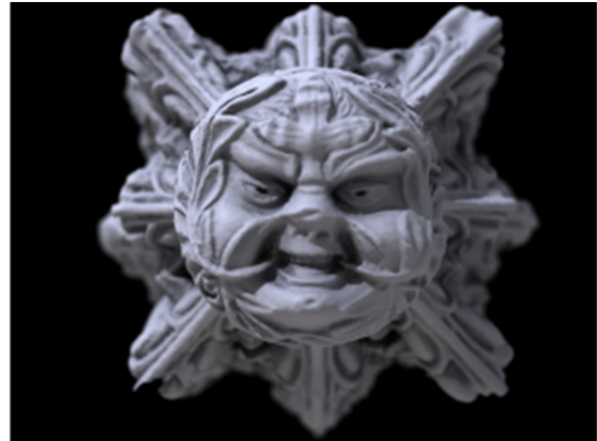
Image Eleven: Detail rendering of the Green Man sculpture
